THERMOMECHANICAL FATIGUE
CHARACTERIZATION OF AN ANGLE PLY
METAL MATRIX COMPOSITE

THESIS

Wade H. Vaught, First Lieutenant, USAF

**In Partial Fulfillment of the
Requirements for the Degree of
Master of Science in Aeronautical Engineering**

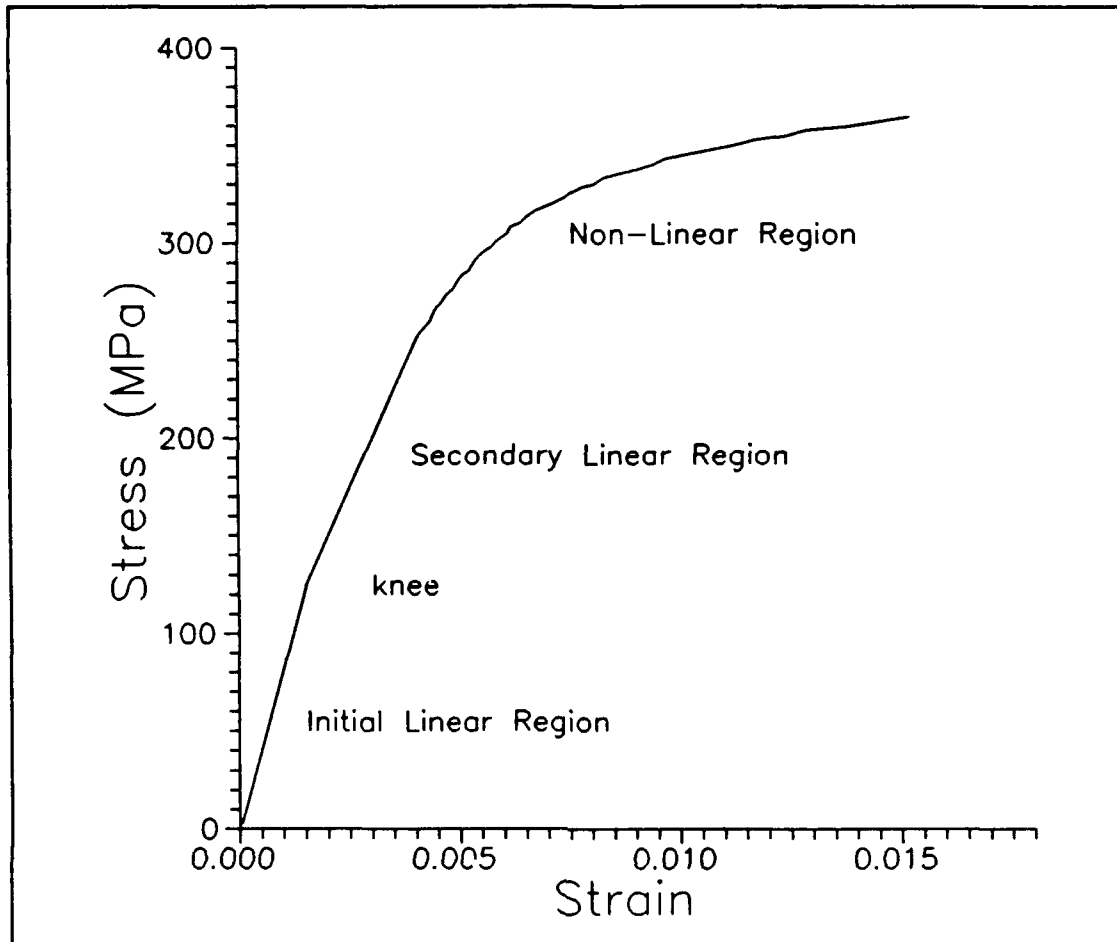
A unique characteristic of titanium-based metal matrix composites containing off-axis plies (plies with fibers oriented other than zero degrees) is the bi-linear stress-strain response (10:203). Figure 2 shows this bi-linear region in a typical stress-strain curve for a $[\pm 45]_2$ SCS-6/Ti-15-3 laminate.

Figure 2. Typical Stress-Strain Curve for $[\pm 45]_{2s}$ Laminate

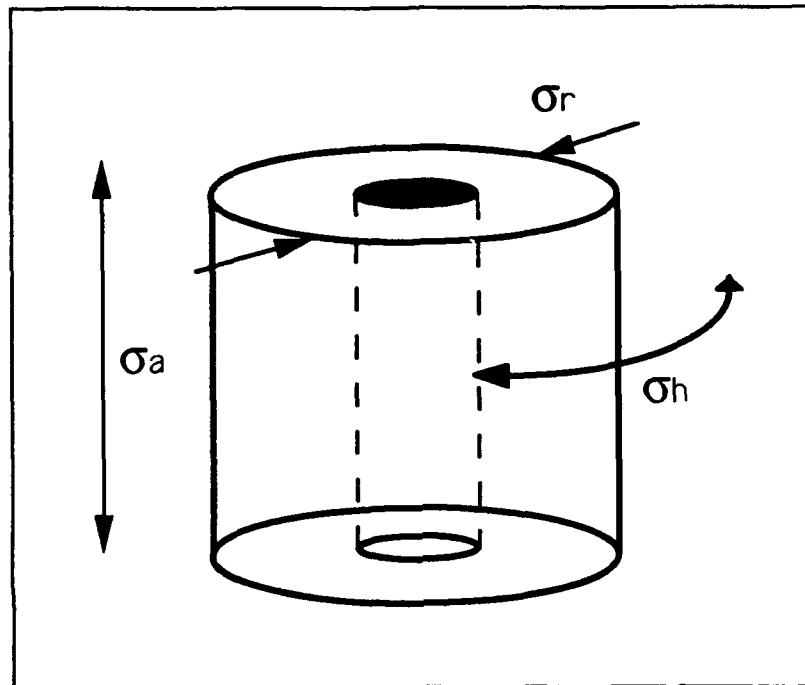
temperature, while the axial and tangential components of the residual stress remain tensile; thus, the matrix is effectively choking the fiber (23:400). Figure 3 shows the triaxial state of stress at the fiber-matrix interface.

Figure 3. Triaxial State of Stress at the Fiber-Matrix Interface

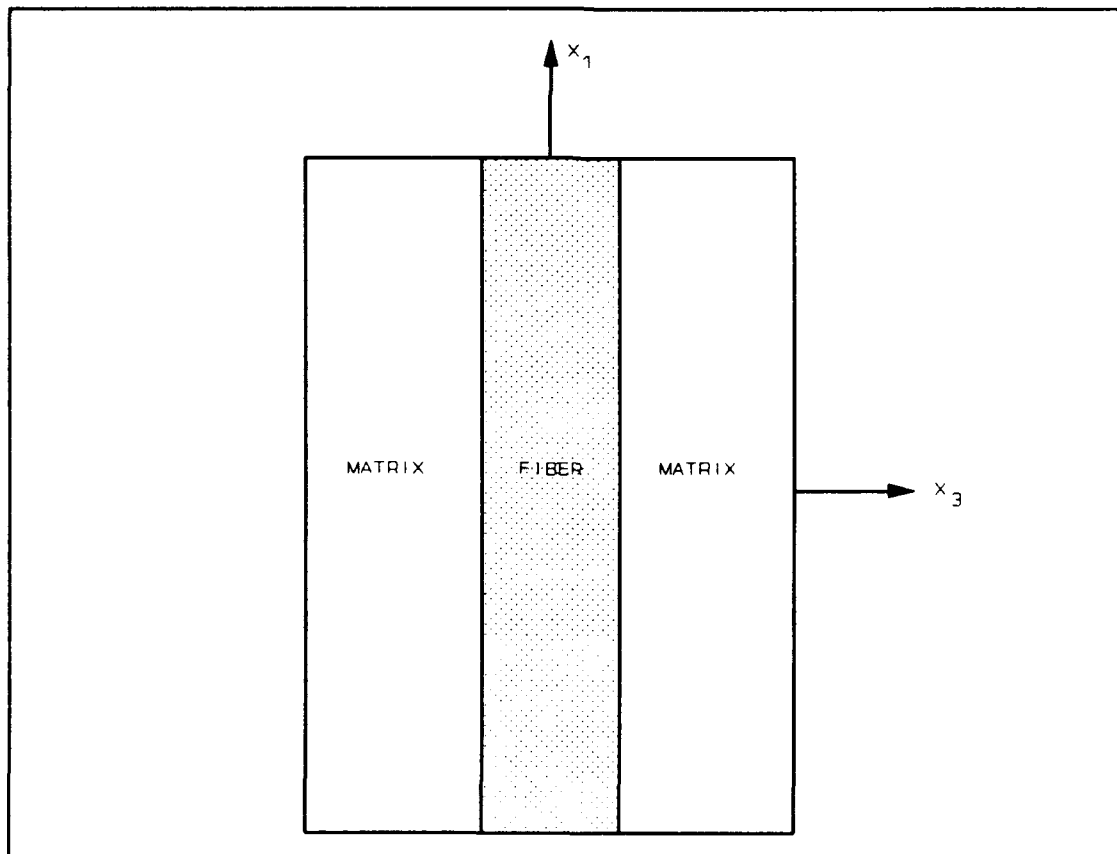
Bigelow (1:21-22,26) summarizes the AGLPLY program and the Vanishing Fiber Diameter model upon which it is based. The AGLPLY program is based on the constituent properties of the fiber and matrix. The model assumes a regular square array of fibers, that all fibers are identical, continuous and parallel and that the bond between the fiber and matrix is perfect. Figure 4 shows the two-dimensional fiber-matrix model used in AGLPLY. While the fiber is assumed to be perfectly elastic, the matrix may have elastic-plastic properties. The material properties of both the fiber and matrix are input as a function of temperature. The interpolated

Figure 4. AGLPLY Fiber-Matrix Model

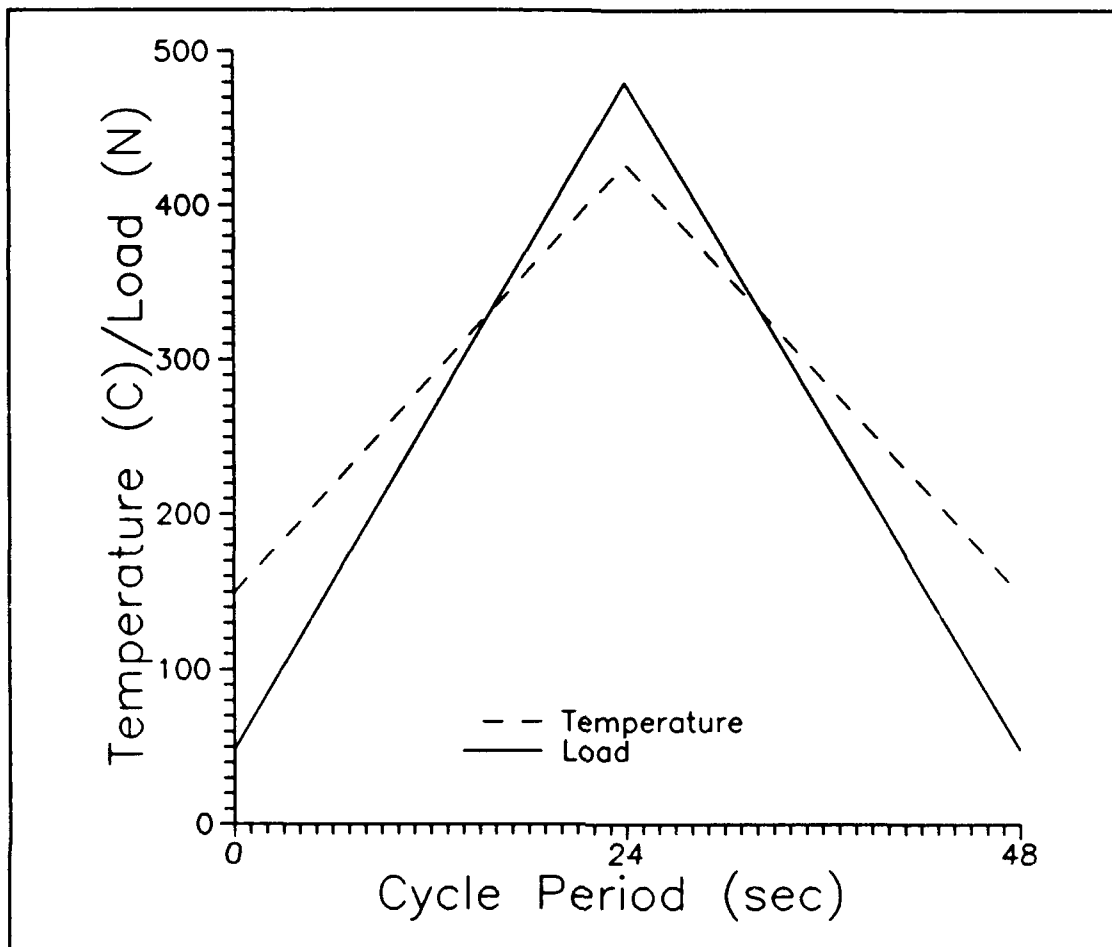
thermal profiles were both triangular, with the maximum applied load and maximum temperature occurring at the same time. Figure 6 illustrates ideal load and temperature profiles with no phase error. All tests were conducted under load control at minimum to maximum load ratio of 0.1 with a cycle period of 48 seconds (.021 Hz). Stress, strain and temperature data for selected cycles was recorded during testing. In addition to the TMF tests, one other specimen was mechanically cycled three times and then failed in tension at 427 C. The objective of this test was to

Figure 6. Ideal Load and Temperature Profiles

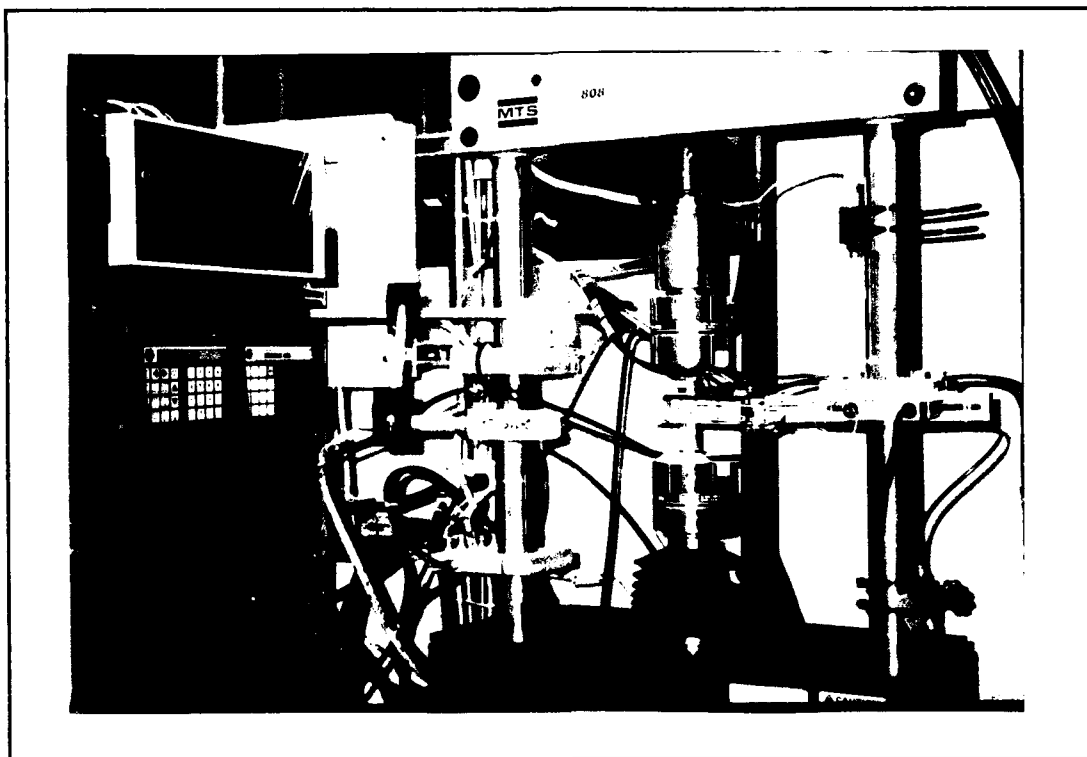
Computer Control System. As mentioned earlier, MATE263 run on a Zenith 248 personal computer was the test software used for overall test conduct and control. MATE263 was specifically designed for load-controlled thermomechanical fatigue testing using the test set-up described here. It was developed in 1990 by Mr. George Hartman of the University of Dayton Research Institute. The program allows for TMF testing over any range of load and temperature, with any phase relation between the two. Inputs into the program include test specific parameters such as specimen dimensions, maximum stress, load ratio, temperature range and cycle time and system specific parameters such as maximum load range and extensometer gauge length and displacement range. Once the thermomechanical cycling begins, the program simultaneously monitors temperature, load and displacement readings from the various components and calculates stress and total strain. At selected cycle intervals, stress, total strain and temperature are recorded for each data point acquired in the cycle and saved in a data file.

Figure 7. Experimental Test Set-Up

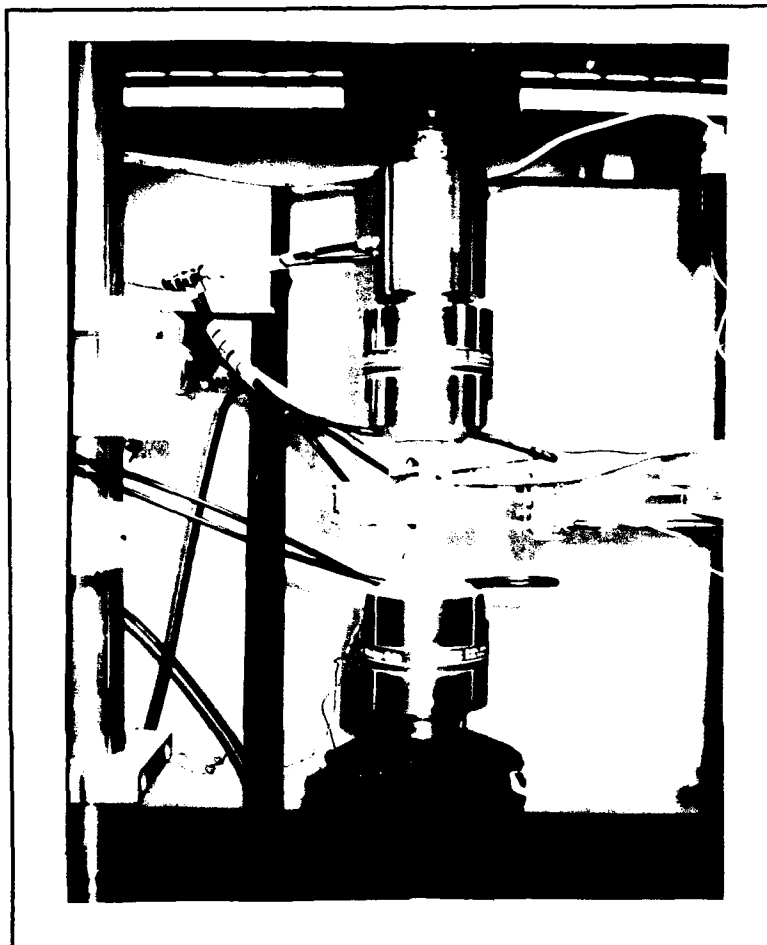
a test specimen mounted in the grips with the extensometer in position.

Figure 8. Mounted Test Specimen

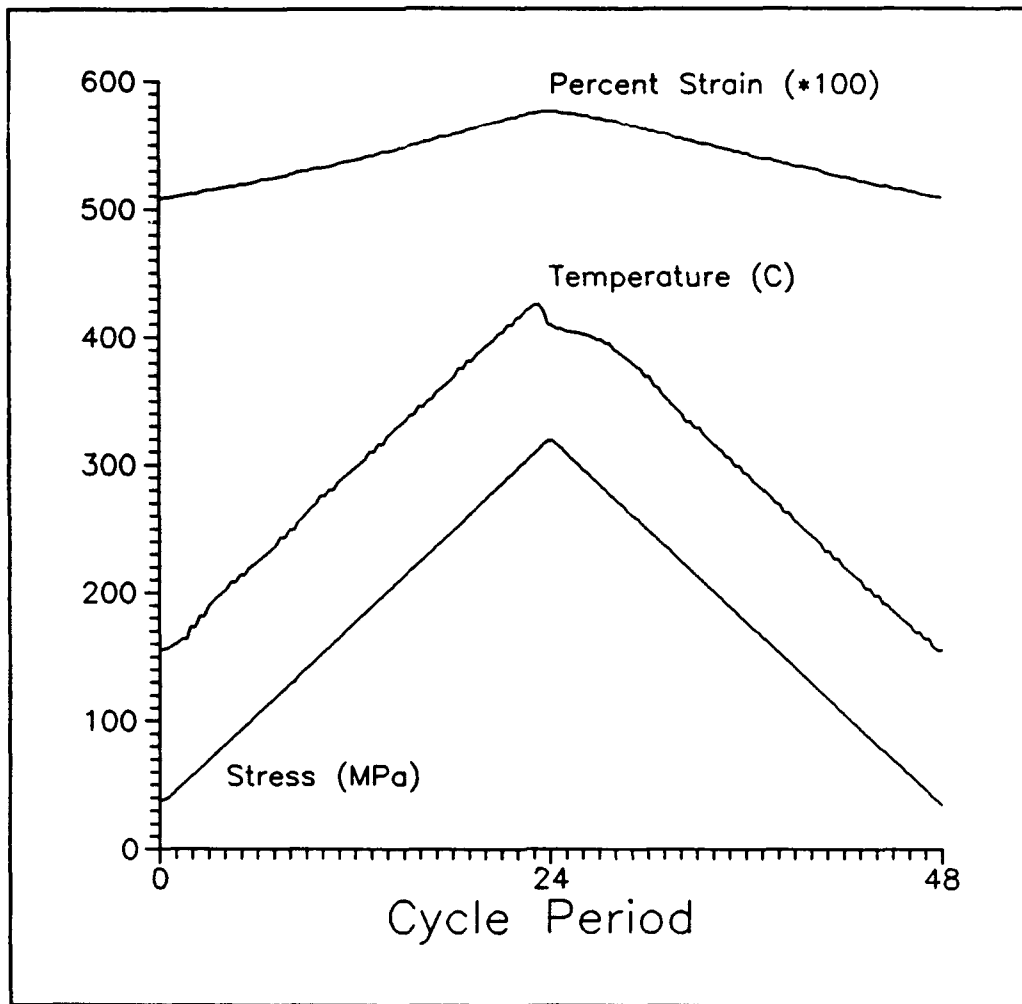
The combination of quartz lamp heaters and active air cooling provided good control of the temperature profiles

Figure 9. Actual Test Cycle Data

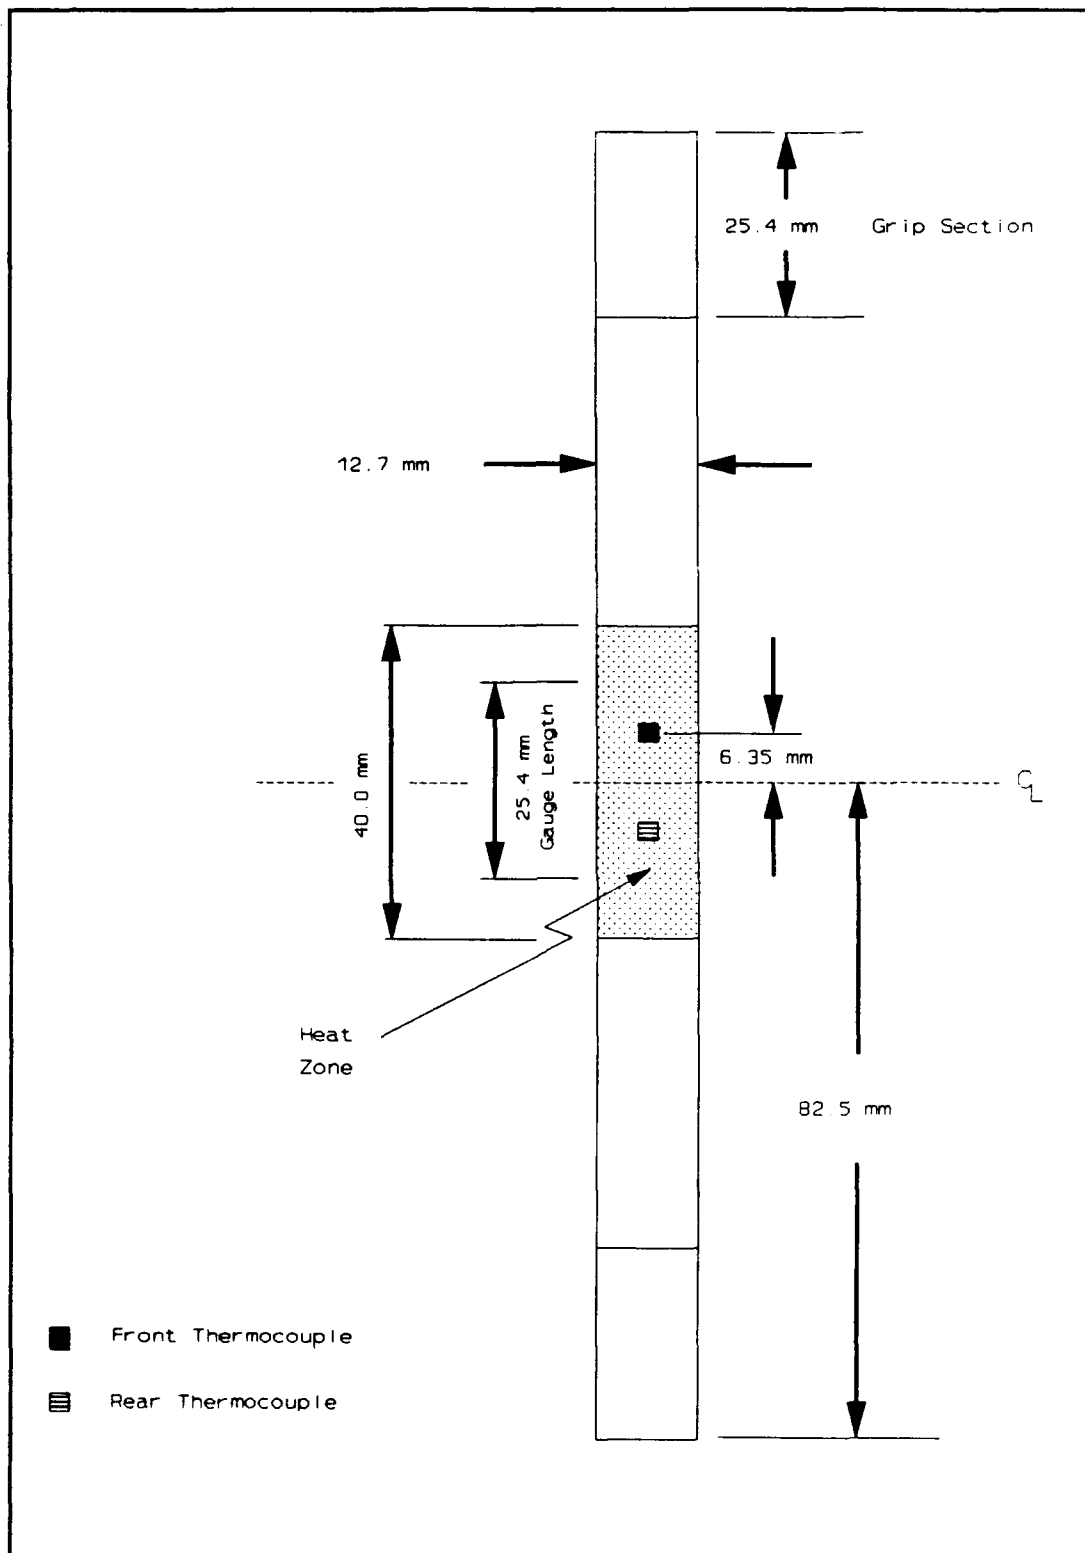
After specimens were cut, aged and polished as described previously, thickness and width measurements were taken to obtain average dimensions for the specimen. The heat zone, gauge length and thermocouple positions were carefully measured and marked. The heat zone was extended beyond the gauge length of the extensometer, ensuring that axial displacement was measured over the heated region. The test specimen was next aligned and mounted in the MTS test stand and thermocouples welded in the heat zone. One thermocouple was spot-welded on each side of the specimen, one offset 6.35 mm above the center line and the other, on the opposite side, offset 6.35 mm below. In this way, the two thermocouples would measure average temperature over the entire gauge length. Figure 10 shows a schematic of a typical test specimen with thermocouple locations. Next, the extensometer was adjusted and mounted against the edge of the specimen at a 25.4 mm gauge length. The extensometer was calibrated and zeroed prior to use. This procedure was repeated several times due to strains exceeding the maximum calibrated displacement of the extensometer. For optimum accuracy, the extensometer should be calibrated just higher than the expected failure strain. Once the extensometer was zeroed and stable, the two lamp heaters were positioned to heat the thermocouple sections on their respective sides. Care was taken to align the lamps horizontally so the heat was transmitted directly to the heat zone and did not

Figure 10. Test Specimen Configuration

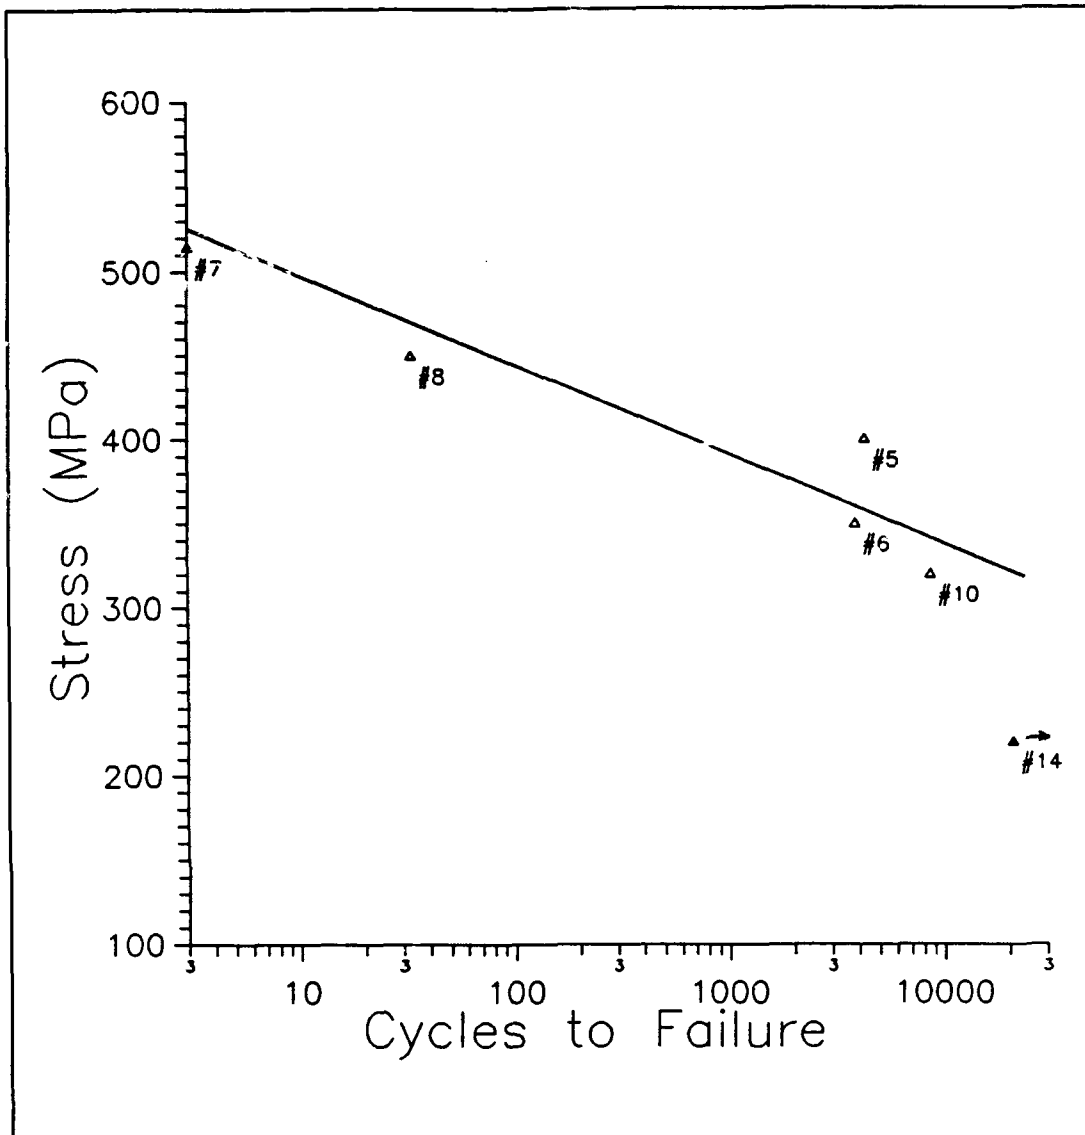
Both the isothermal fatigue test and the TMF tests specimens exhibited open stress-strain hysteresis behavior during fatigue cycling. Though the stress-strain response stabilized during TMF testing, the open hysteresis behavior continued until failure. This finite hysteresis for each cycle resulted in a gradual, yet constant, accumulation of

Figure 11. In-Phase Fatigue Life

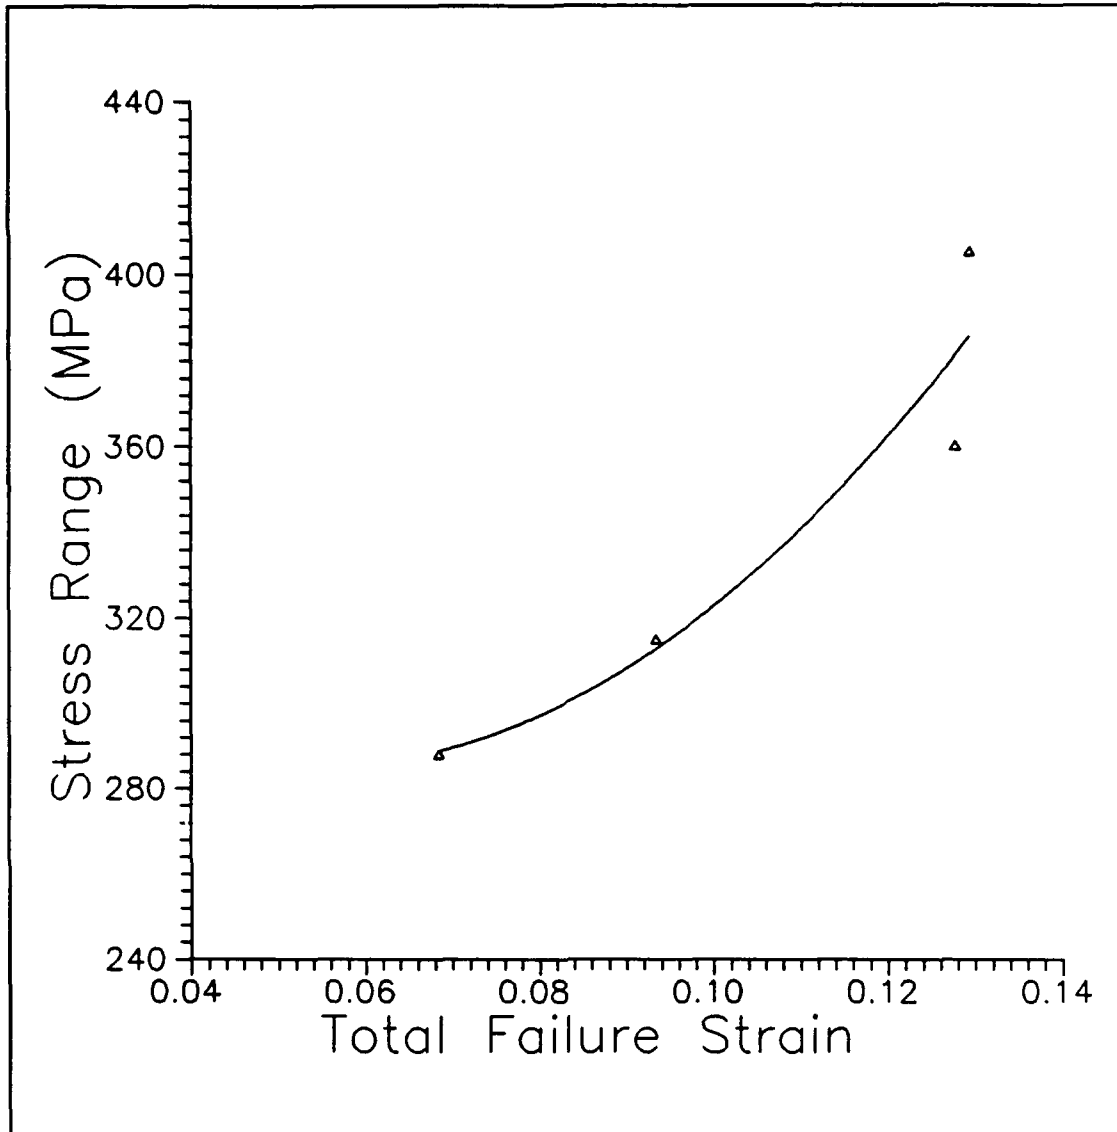
The failure in the TMF specimens was characterized by matrix cracking and plasticity and extensive fiber-matrix debonding, regardless of the maximum cycle stress. The dominant role of the matrix in failure was also revealed by the high failure strains (over 12 percent in one test). The impact of applied cycle stress was seen primarily when comparing the extent of fatigue crack progression and the extent of tensile overload damage in the matrix. Lower cycle stress levels provided increased cycle life which allowed fatigue damage to progress further through the matrix.

Figure 12. Fatigue Stress Range vs. Total Failure Strain

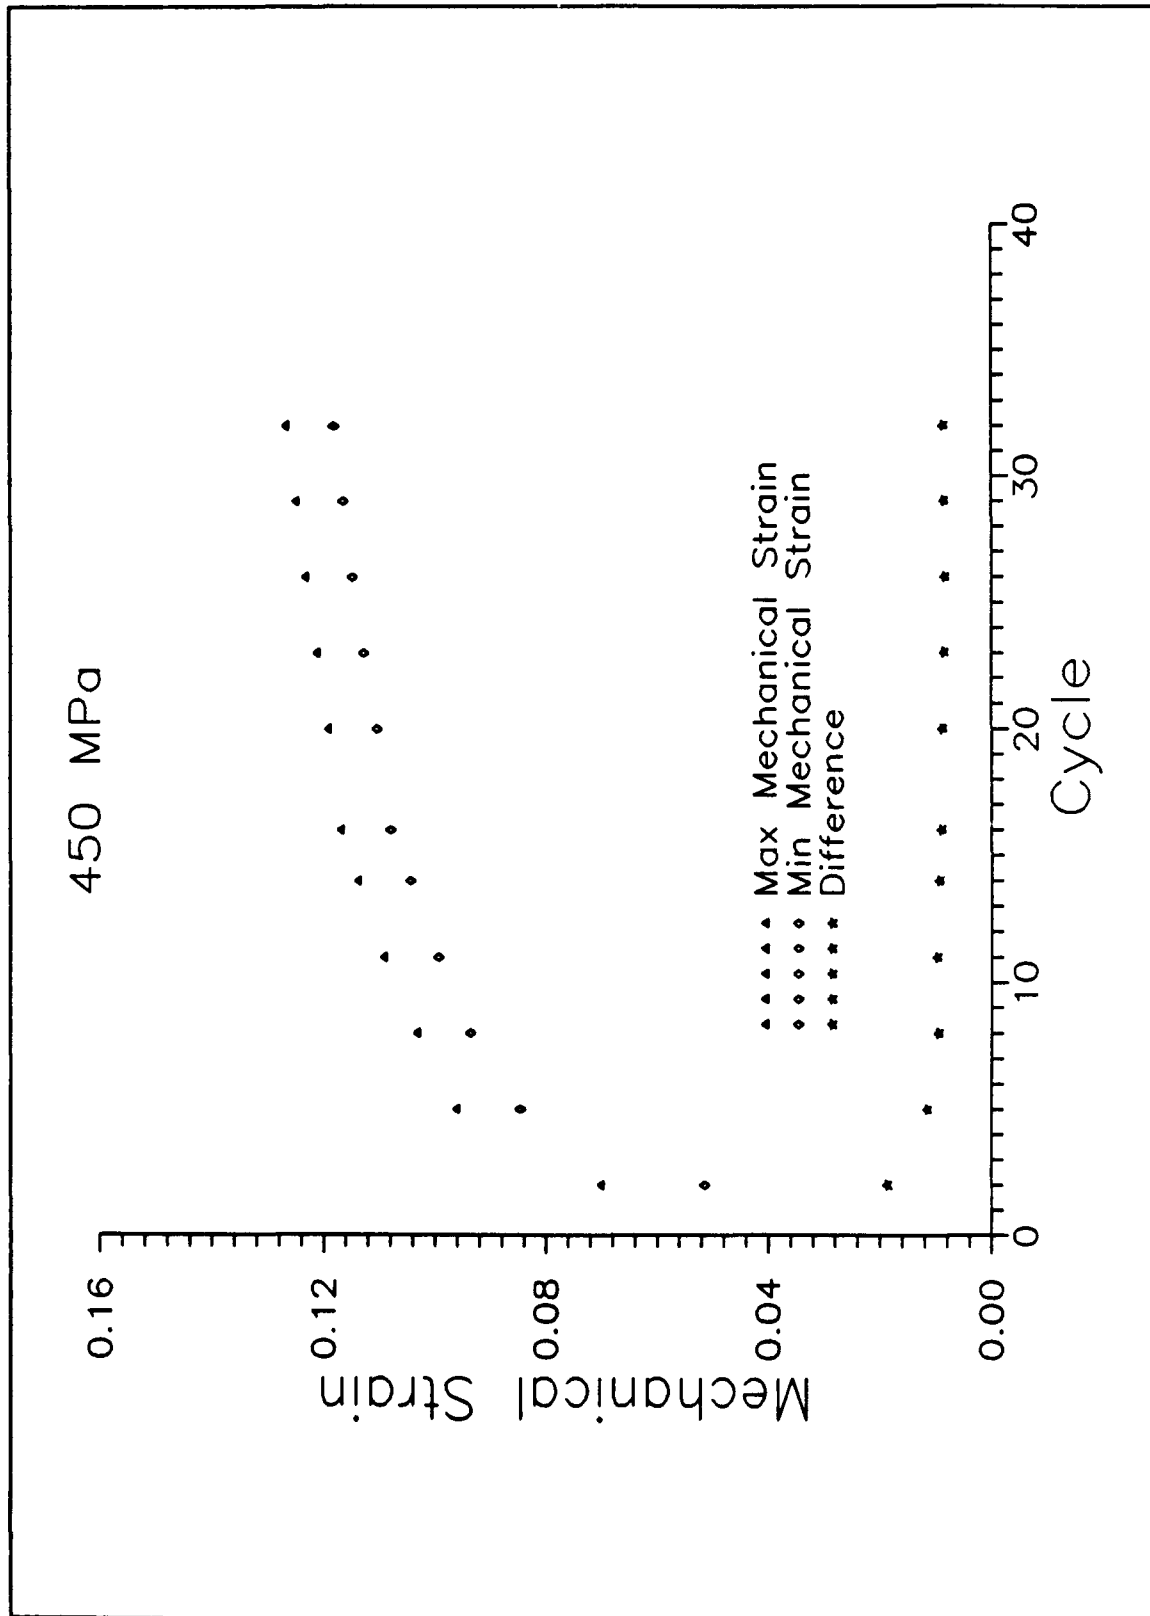
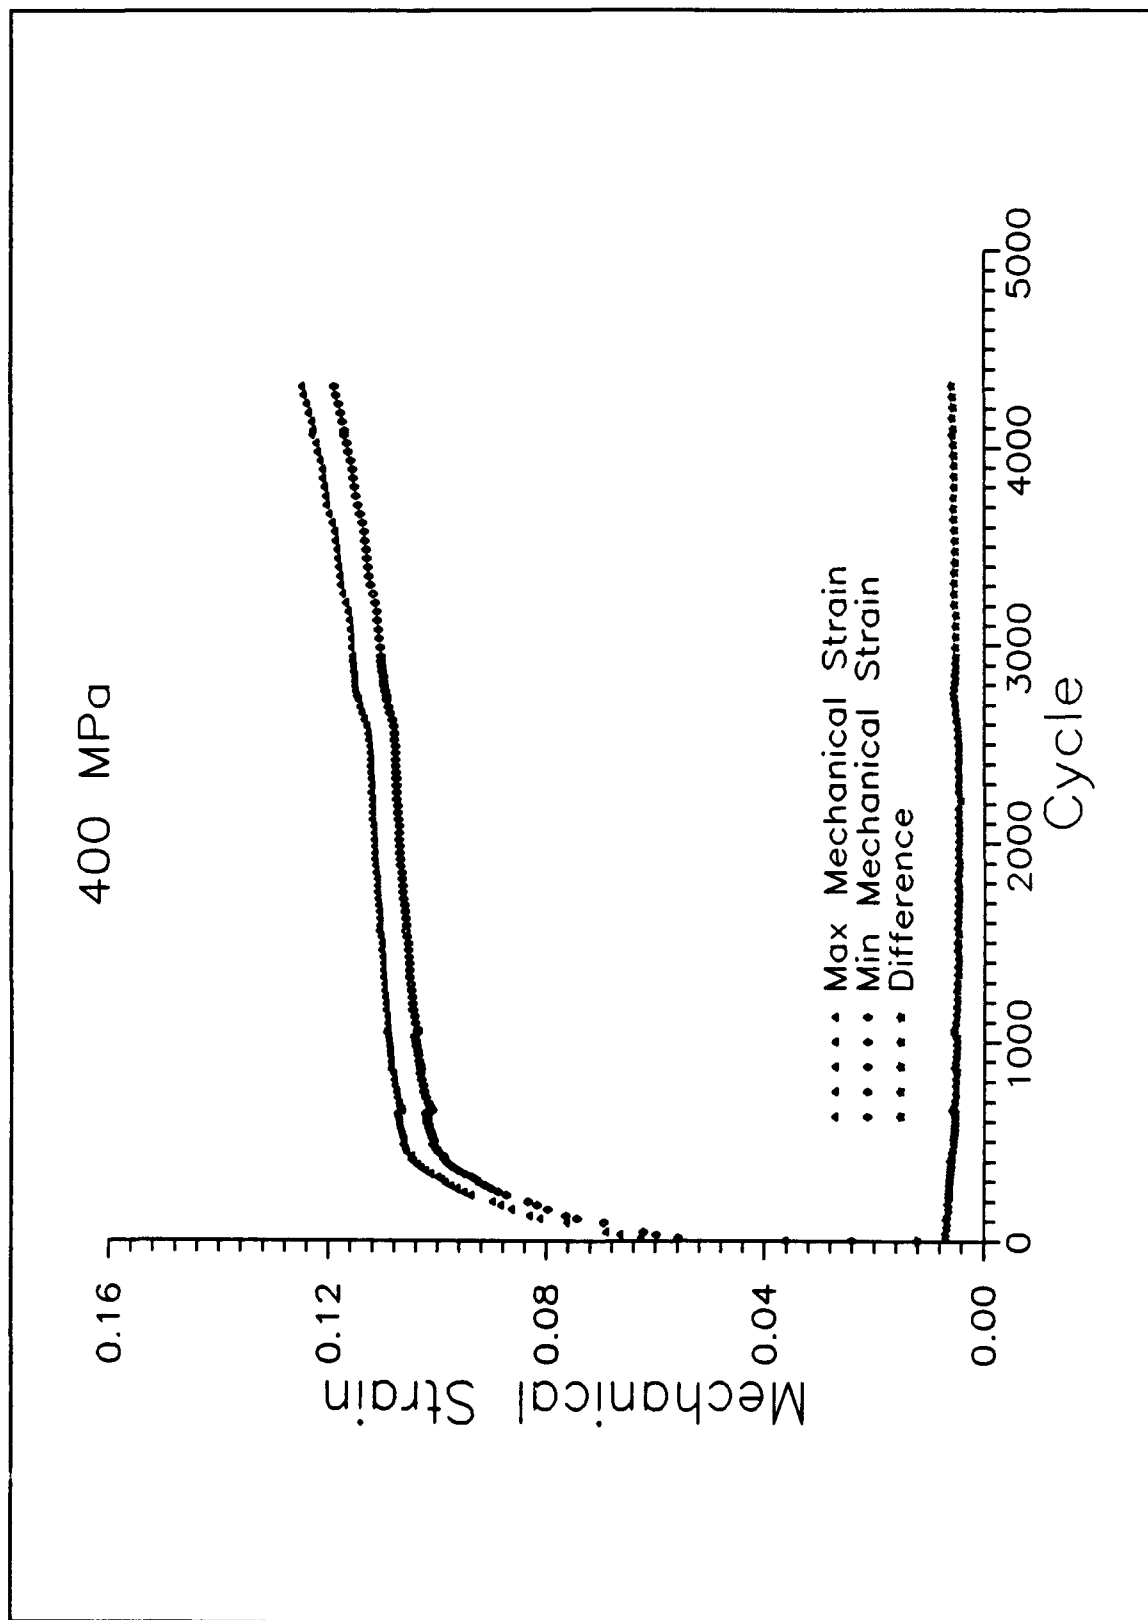
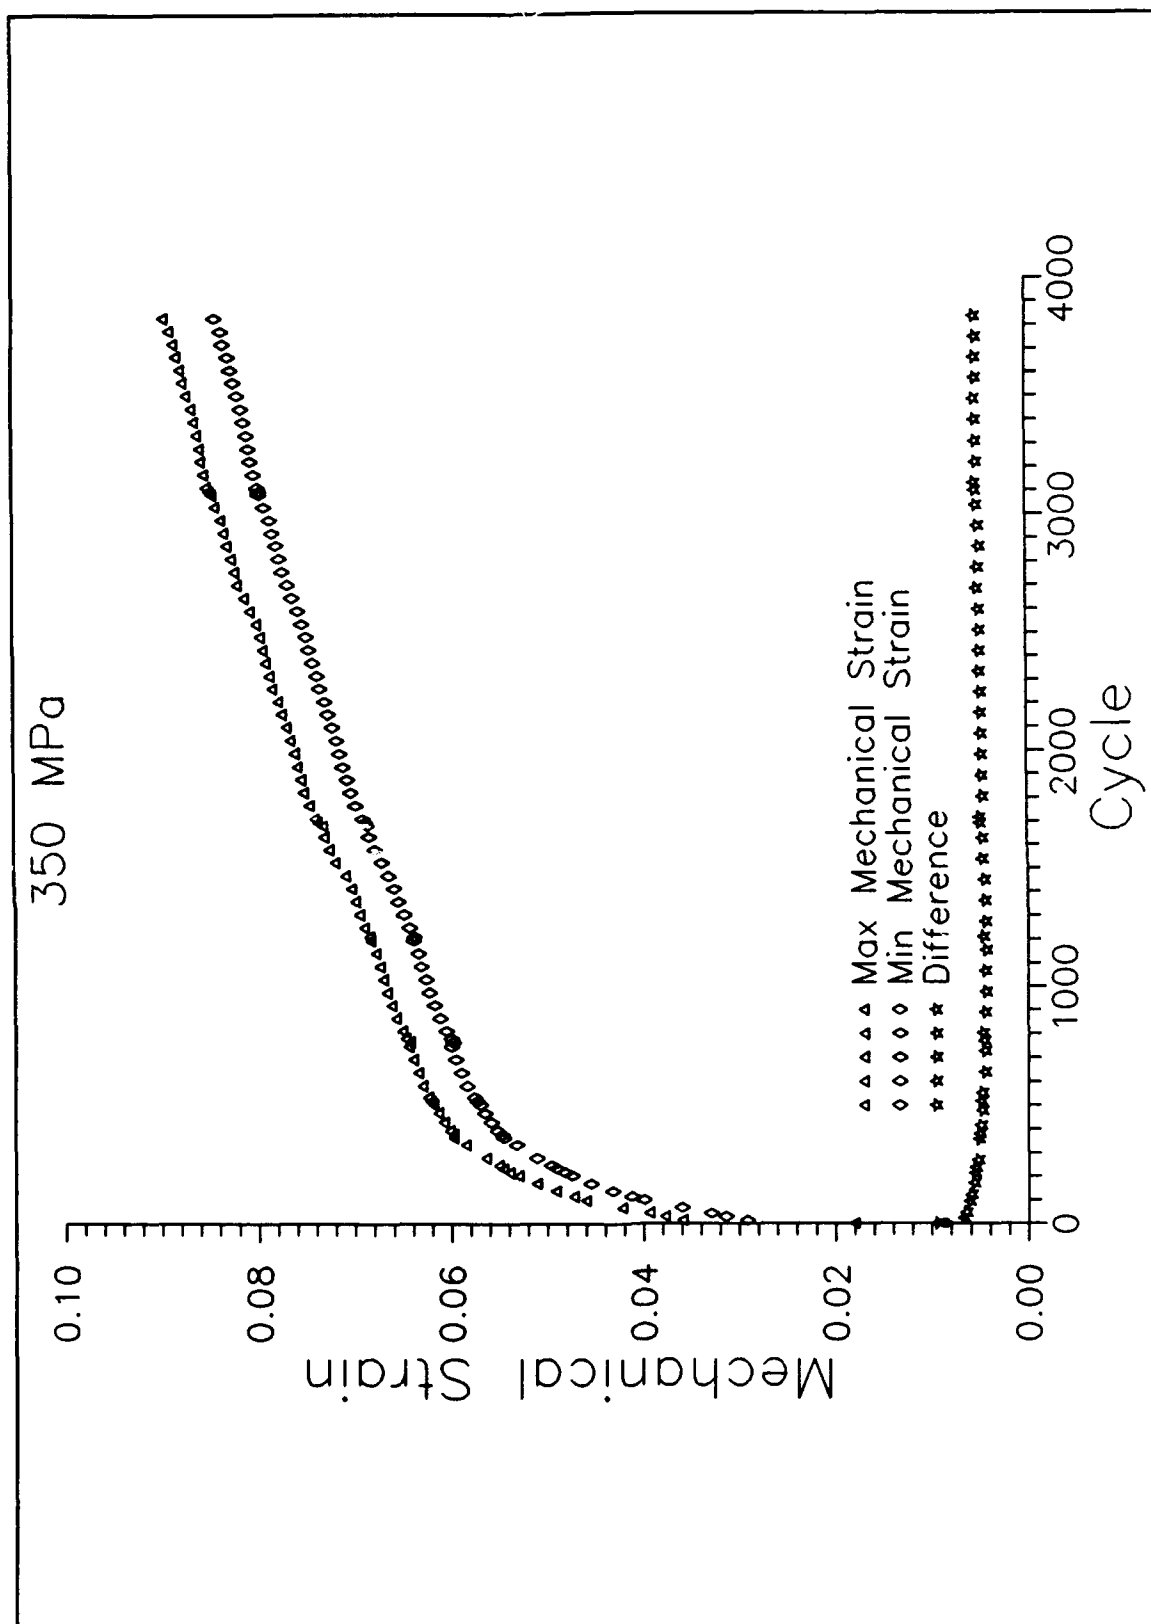
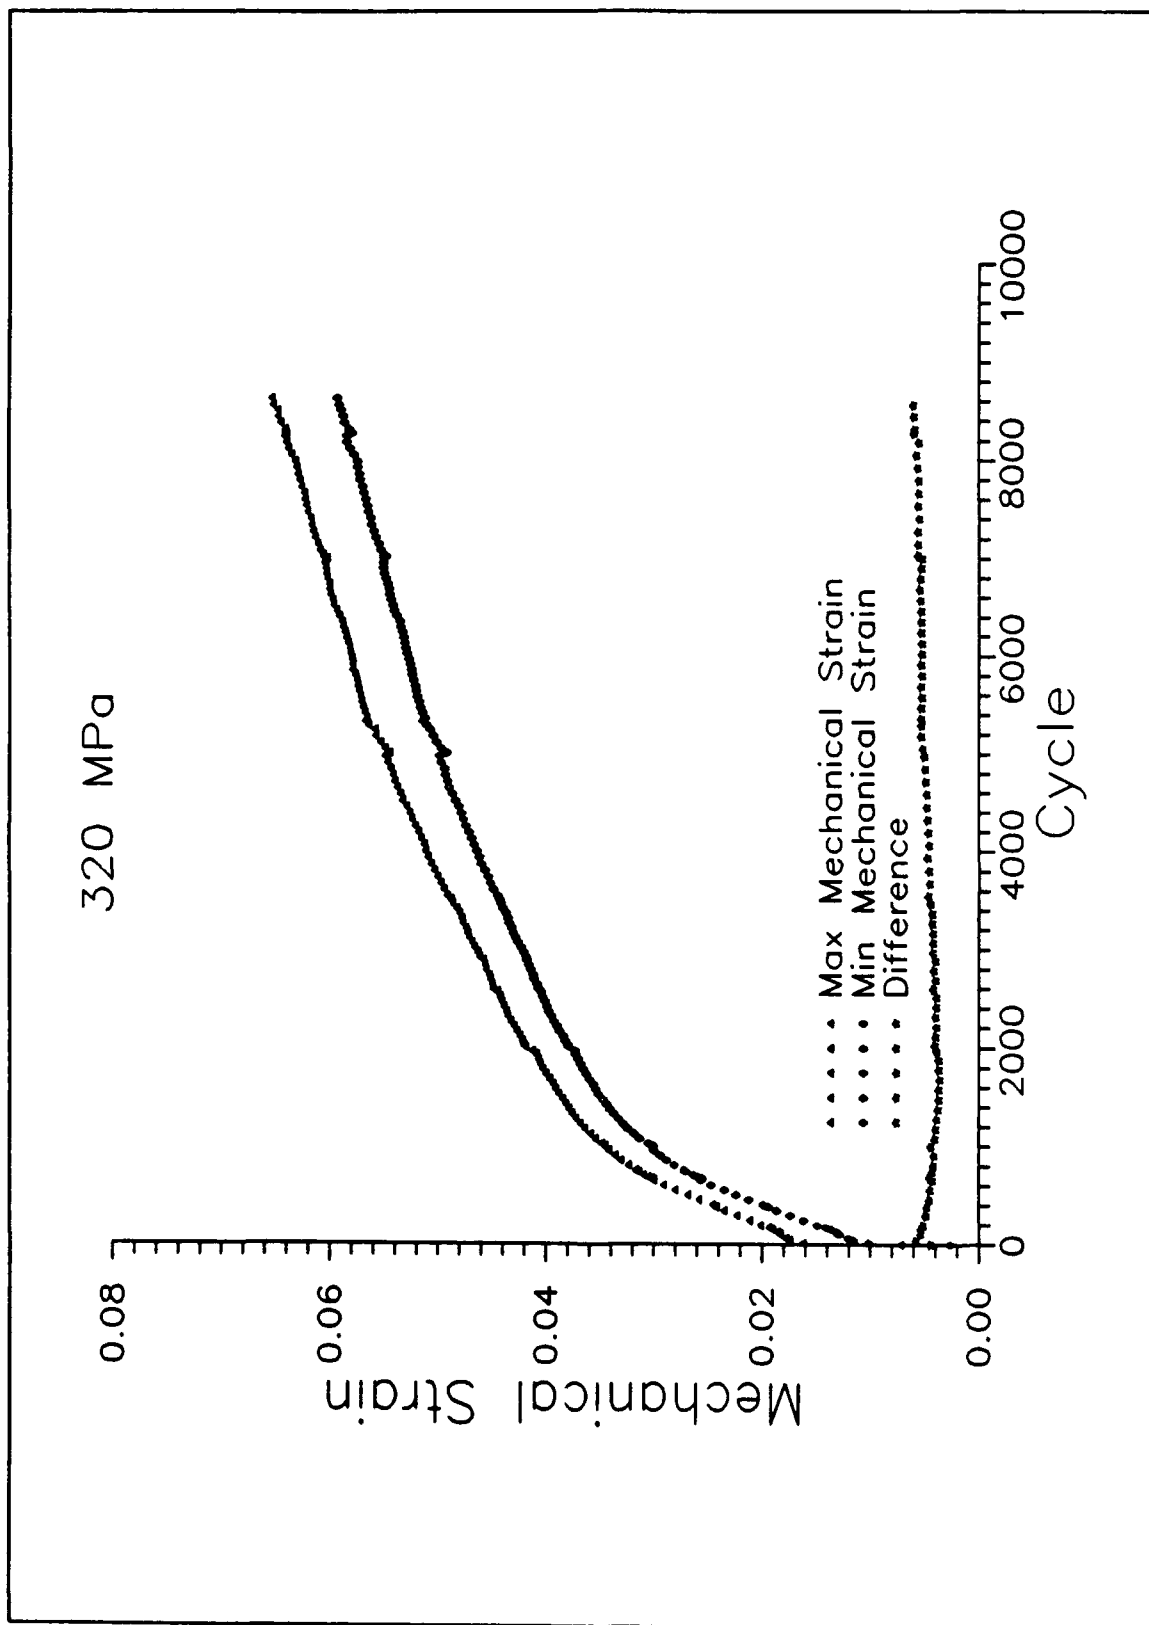
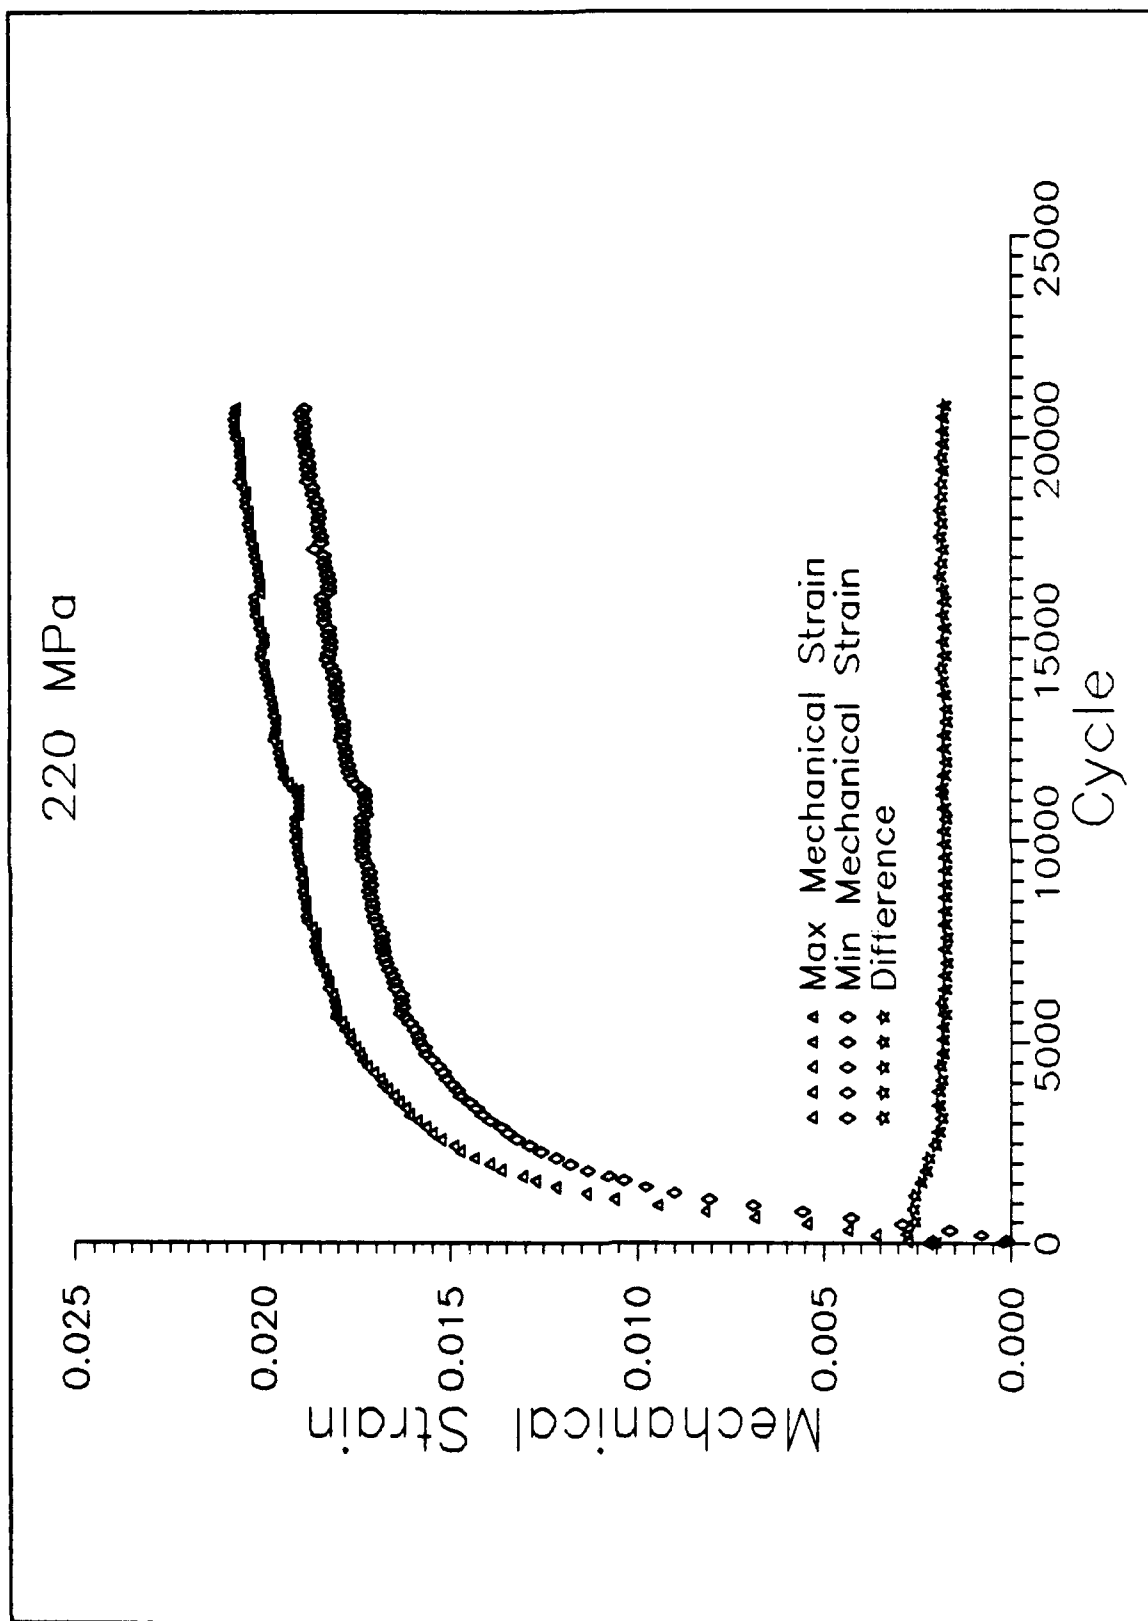
The strain histories for each fatigue test are presented in Figures 13 through 17. The maximum and minimum mechanical strain and the difference between the two is shown as a function of cycle life. There are general trends common to all test specimens, independent of the maximum cycle stress. First, there is an immediate and rapid accumulation of strain during approximately the first ten percent of the specimen cycle life. In the case of the 450 MPa and 400 MPa tests, over 80 percent of the mechanical strain at failure was accumulated in the first 30 percent of cycling. The lower stress tests did not exhibit as rapid strain growth during the early cycles, but still showed this to be the fastest period of growth. After this period of rapid strain accumulation, the majority of fatigue life was marked by a slower and very stable growth of the strain. This steady period of strain progression continued until failure. Specimens did not exhibit a rapid and dramatic increase in

Figure 13. Strain Data for 450 MPa Test

Figure 14. Strain Data for 400 MPa Test

Figure 15. Strain Data for 350 MPa Test

Figure 16. Strain Data for 320 MPa Test

Figure 17. Strain Data for 220 MPa Test
